## A Survey of Thatched Buildings in Scotland

Thatch Survey of Scotland  
2014-15

A photographic survey of thatched buildings in Scotland, surveyed between May 2014 and August 2015 by Zoe Herbert (SPAB Scotland Officer), on behalf of the Society for the Protection of Ancient Buildings.

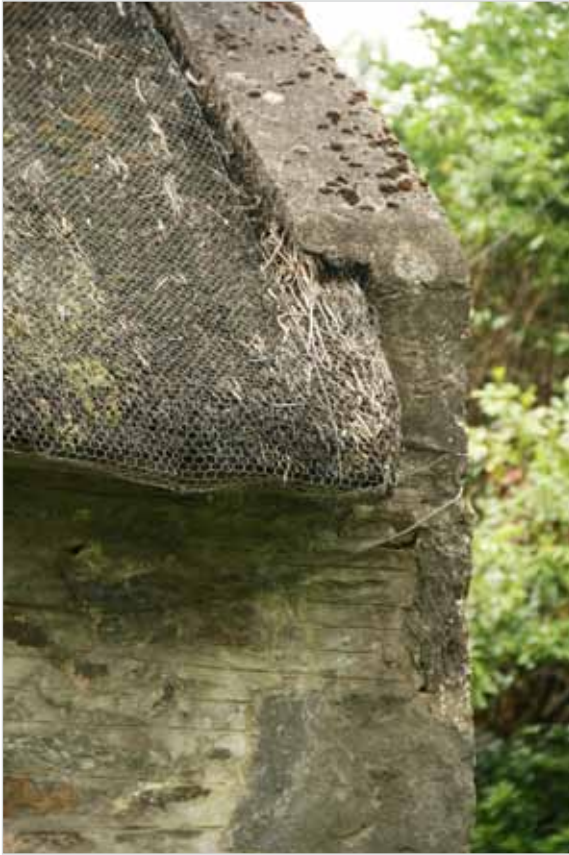
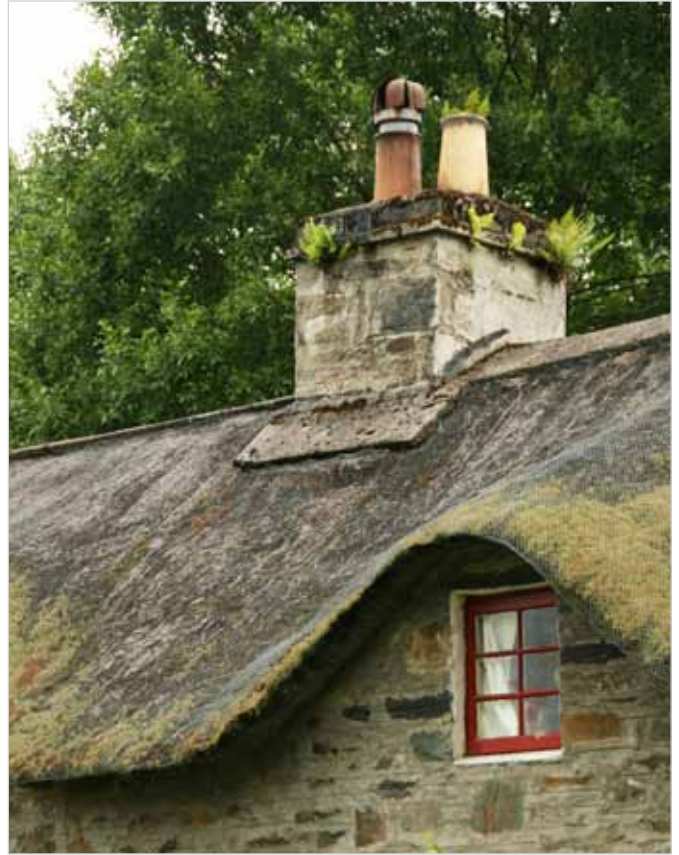
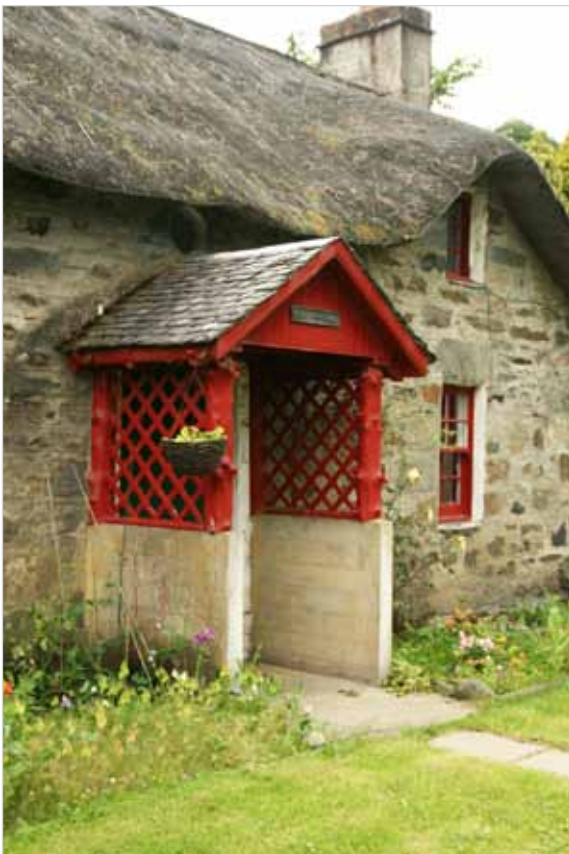
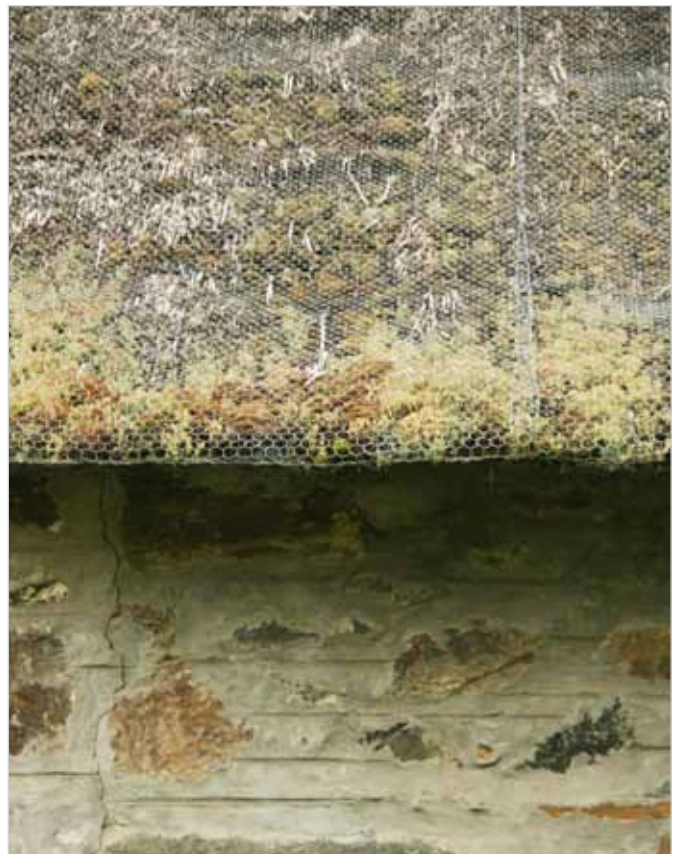
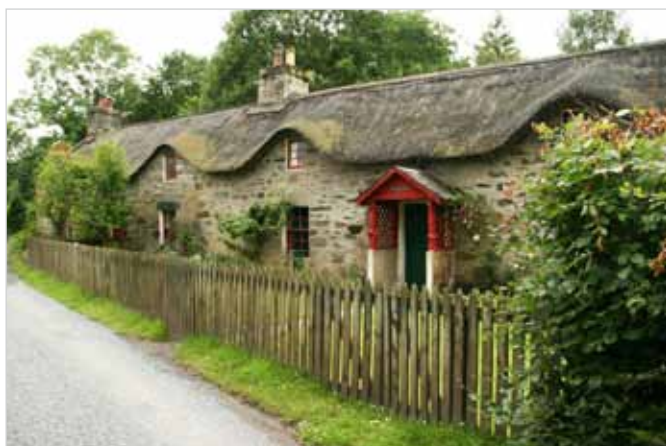
Crachan Cottages – Perth & Kinross

Additional Notes: ..... Circa 1835 single-storey with attic row of cottages, altered after a fire circa 1990. The cottages are listed as having 'thatched roof with striking eyelid dormerheads over attic windows'. The reed-thatched roof which is entirely netted, has a concrete ridge that extends below each of the chimney stacks at both the gable ends and along the ridge. There is an amount of mossy vegetation growth across the surface of the thatch, which is particularly dense across the dormerheads and along the eaves, and there are loose pieces of thatch throughout that have been held to the roof by the netting.

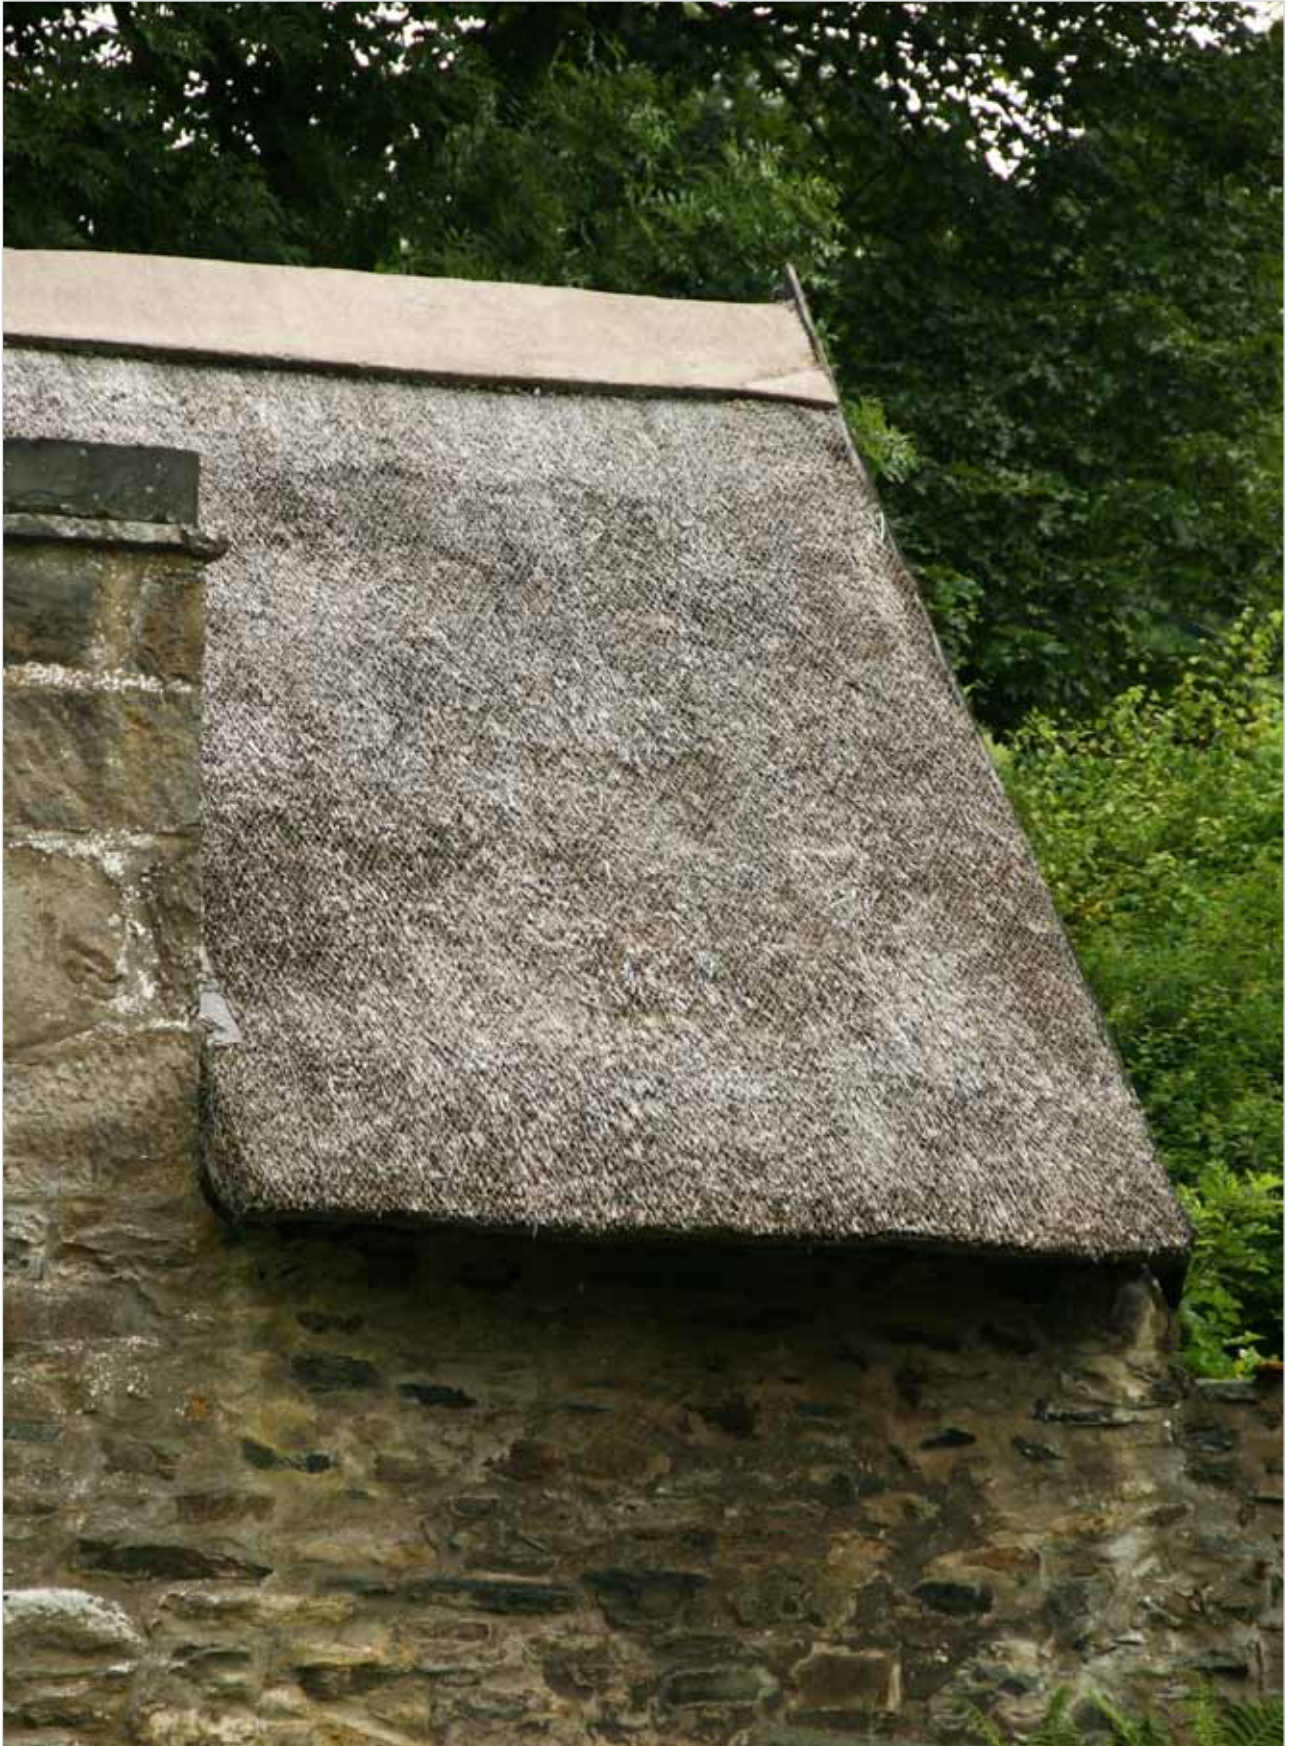
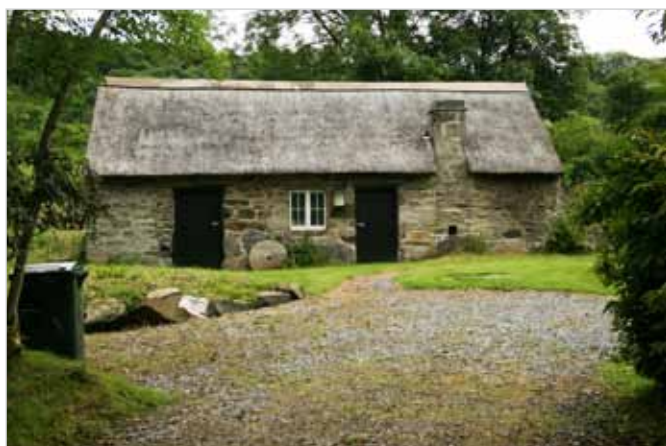
Former Smithy – Perth & Kinross

Address: ..... Former Smithy  
..... Camserney ..... Listing Category: ..... B  
..... Dull ..... Date Listed: ..... 05/10/1971  
..... Listed Building Number: ..... 5738  
Local Council: ..... PERTH & KINROSS ..... Canmore ID: ..... 227379  
..... Building Type: ..... Cottage  
..... Use: ..... Residential  
Grid Reference: ..... NN 81983 49412 ..... Occupancy: ..... Occupied  
Date of Visit: ..... 16/08/2014 ..... Buildings At Risk: ..... n/a  
Thatch Type: ..... Reed  
Ridge Type: ..... Concrete  
Condition of Thatch: ..... Good  
Additional Notes: ..... Part of a group listing of 'Mid 19th century and earlier' cottage, former smithy and limekiln.  
Access to the building could not be gained upon visiting; however the front elevation of the building could be  
seen from the road. The rectangular former smithy has a chimney stack to the front elevation of the building. The  
thatch, which appears to be reed, has been entirely netted and appears to have been boxed in at the skews with

timber.

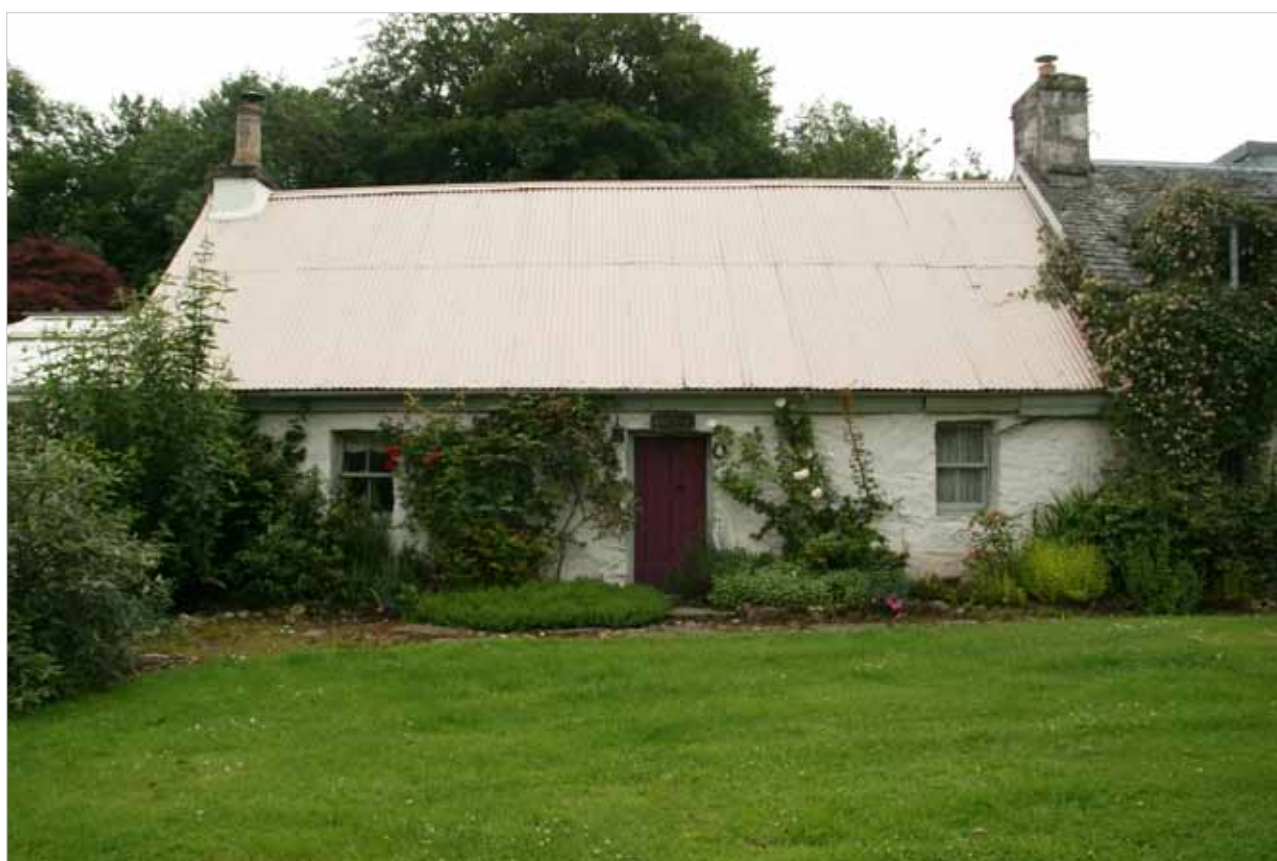
Additional Notes: ..... Probably 18th-century cottage, listed as having a '*remarkably intact*' thatched roof under-  
neath the corrugated iron covering. Internal access could not be gained and therefore the status and condition  
of the thatch could not be confirmed. Further research into this building is required.

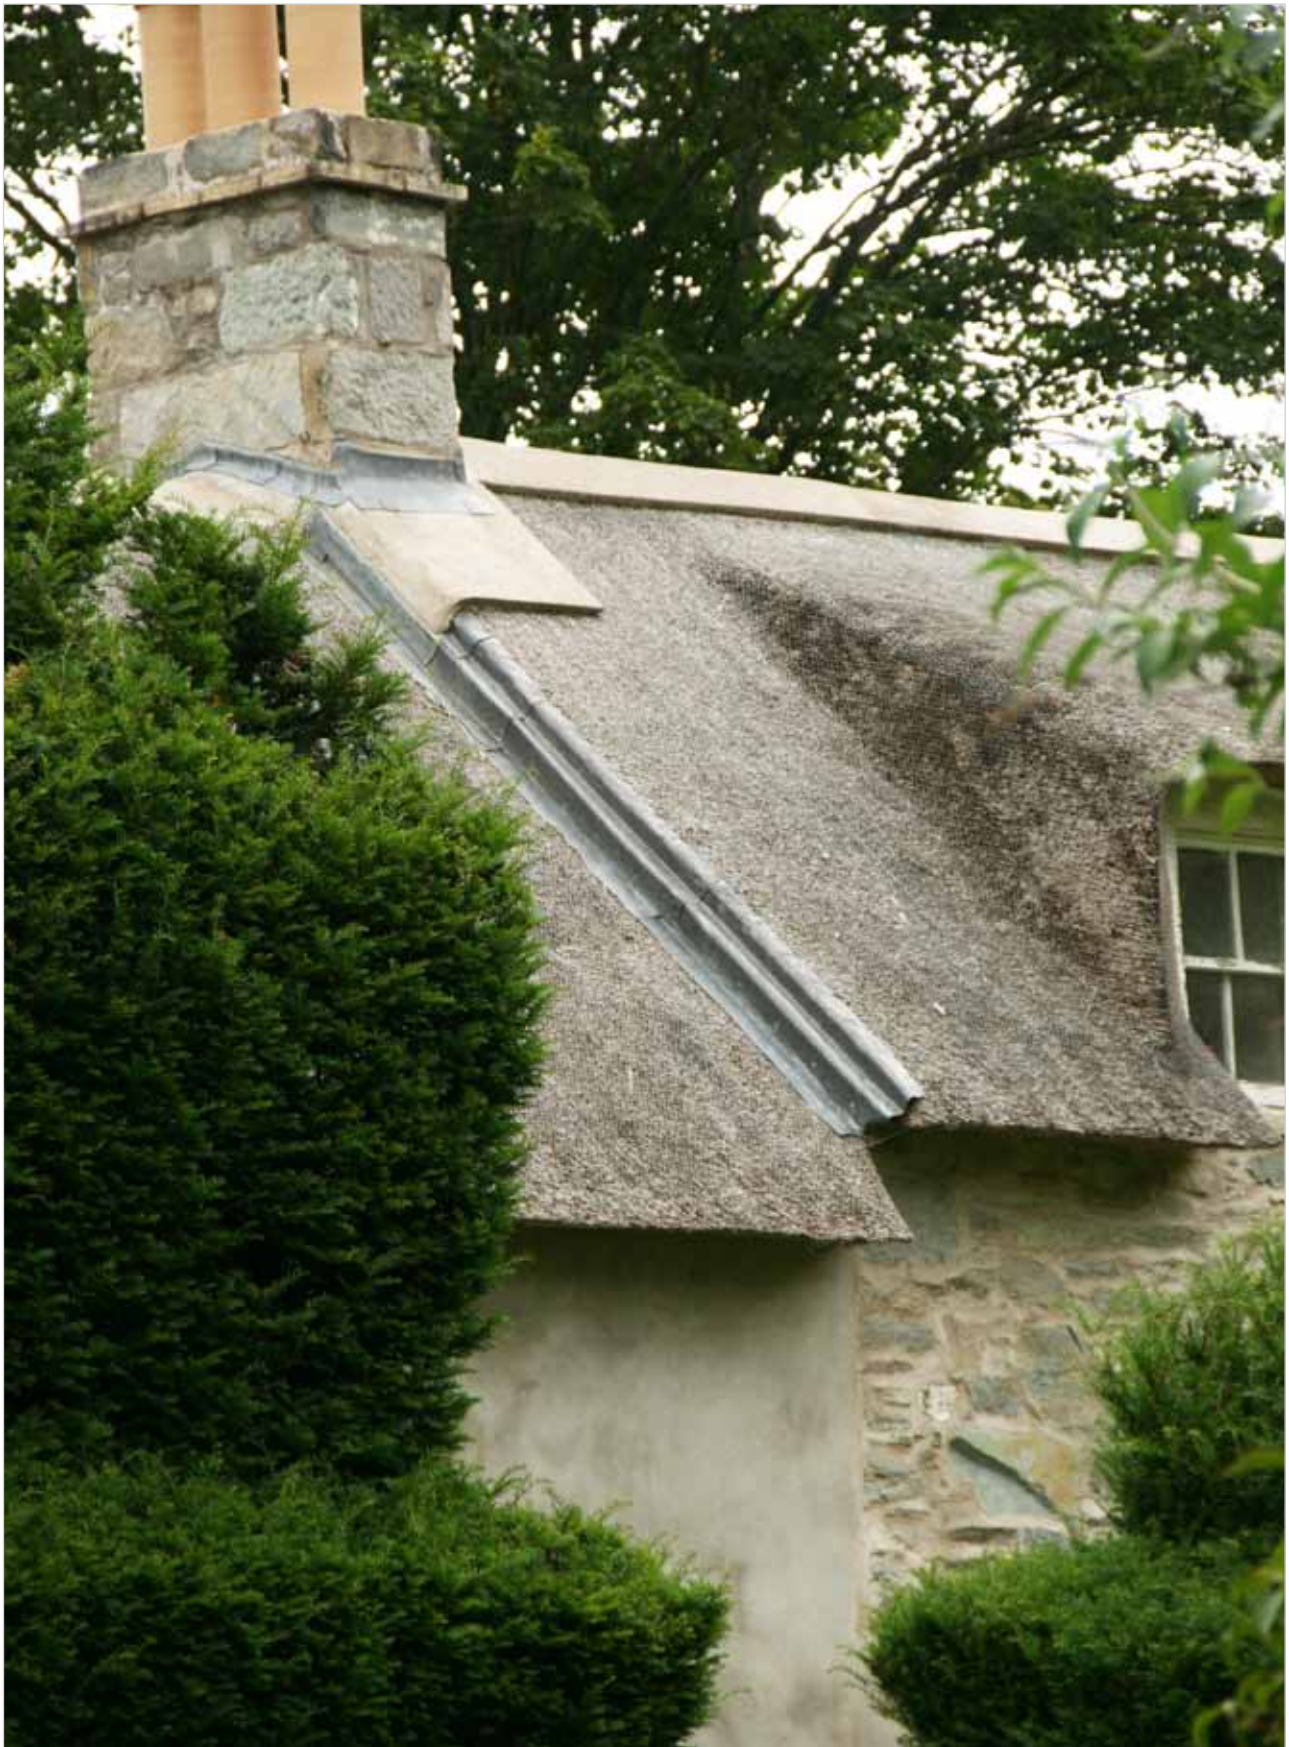
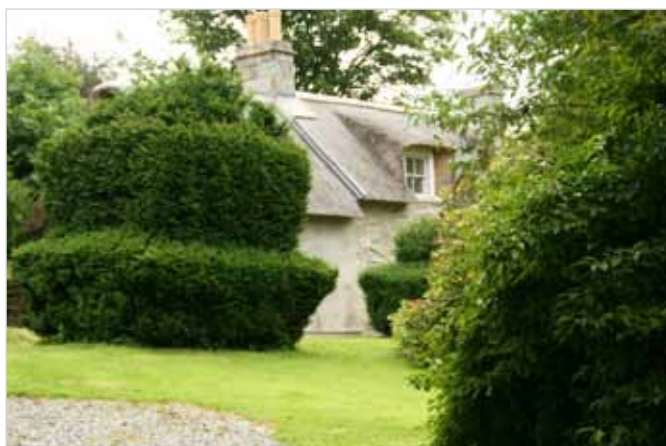
Smithy Cottage – Perth & Kinross

when viewing the building using web-based street view. It can therefore be assumed that the current thatched roof is a relatively modern installation, which its condition would confirm.

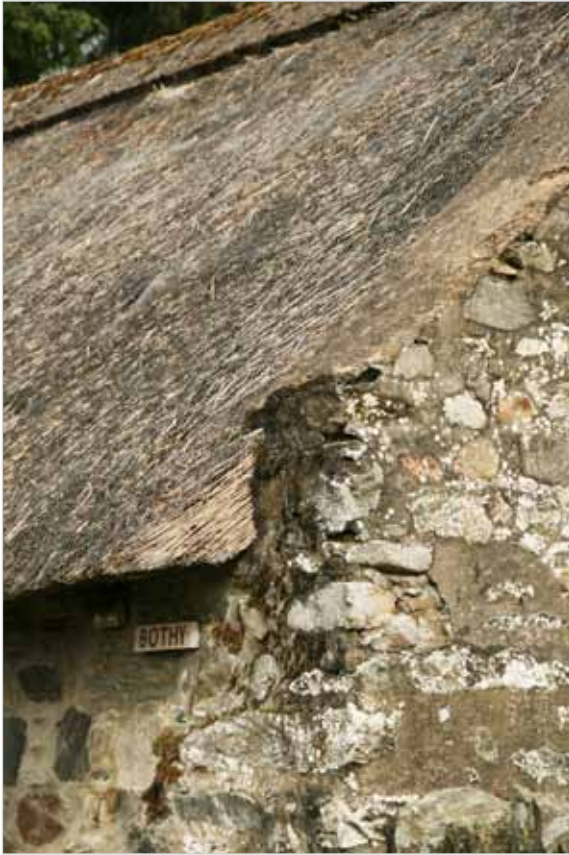
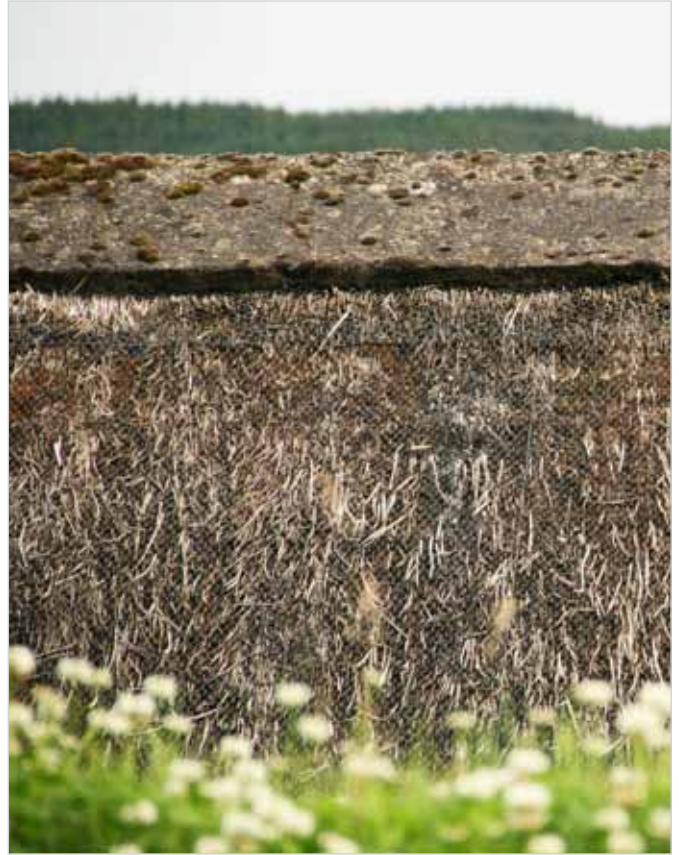
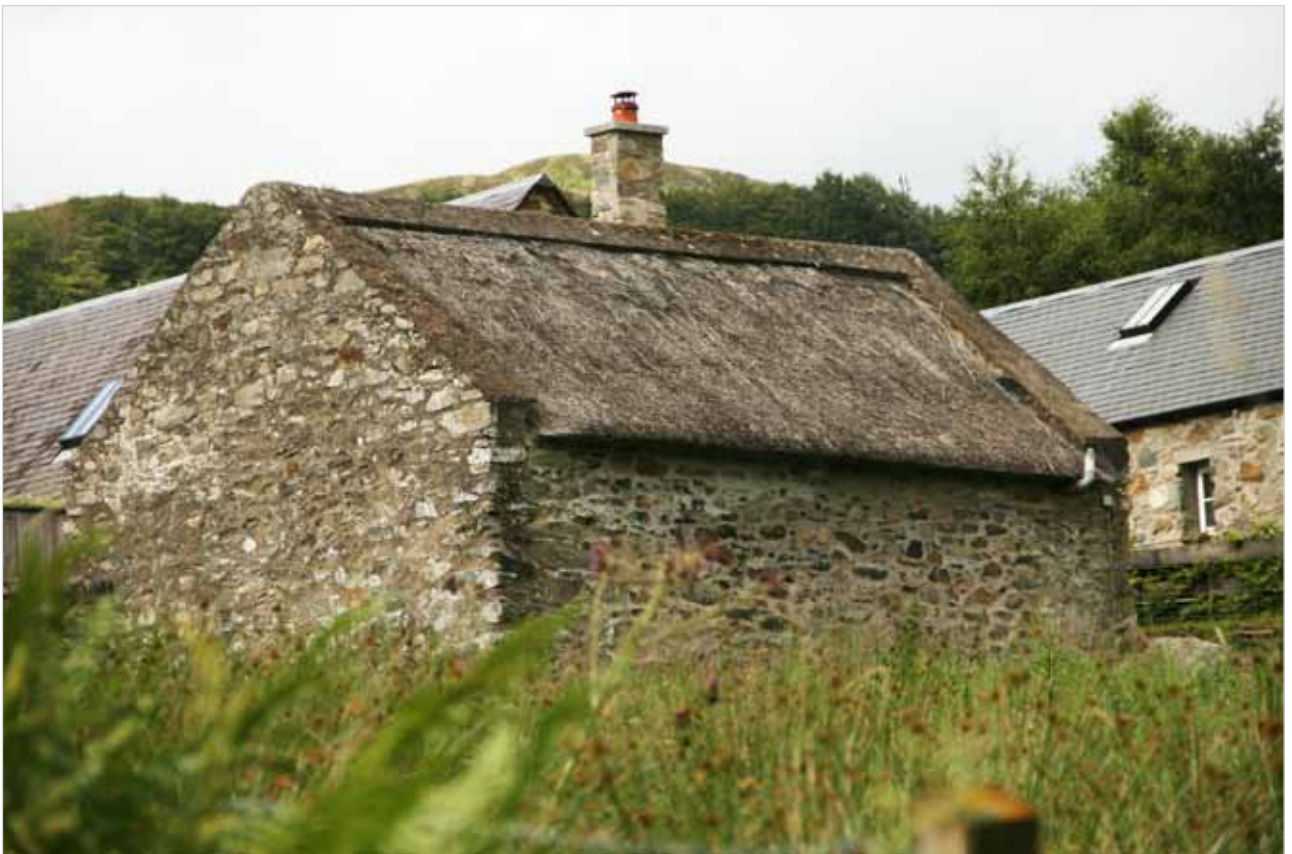
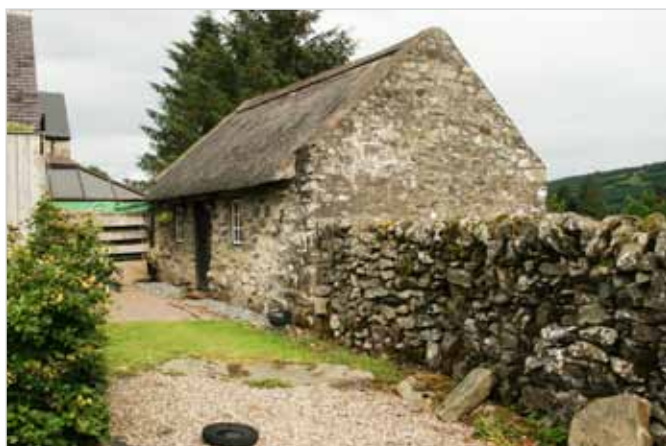
The Bothy – Perth & Kinross

Thatch Type: ..... Straw  
Ridge Type: ..... Concrete  
Condition of Thatch: ..... Good

Additional Notes: Part of a group listing of 18th-century cottage, barn and bothy. The bothy is listed as being  
'converted to dwelling circa 2000' and having a 'replacement thatch with concrete ridge and skewes'. The thatch,  
which appears to be straw, has been entirely netted right up to the ridge, skewes and eaves. There is an amount  
of mossy vegetation growth on the surface of the thatch, as well as along the concrete ridge.

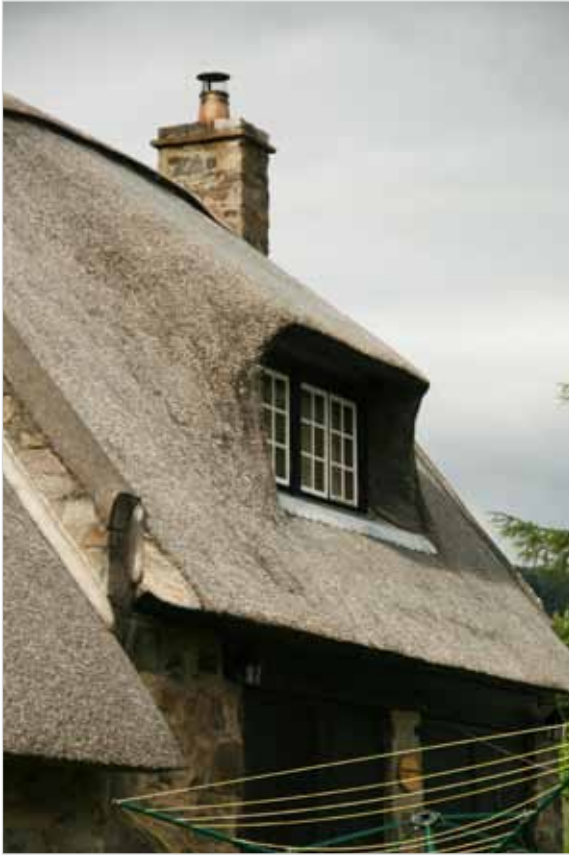
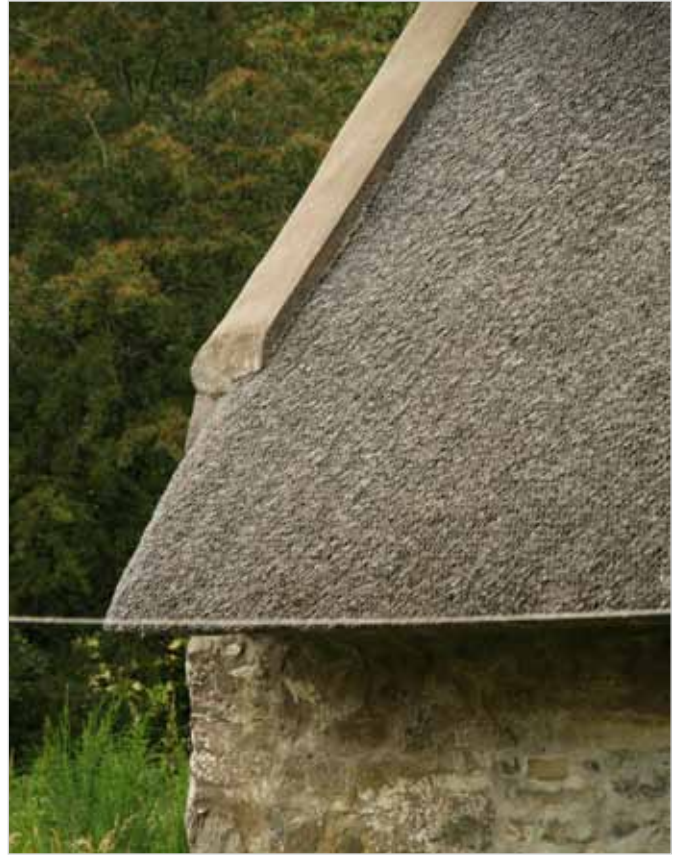
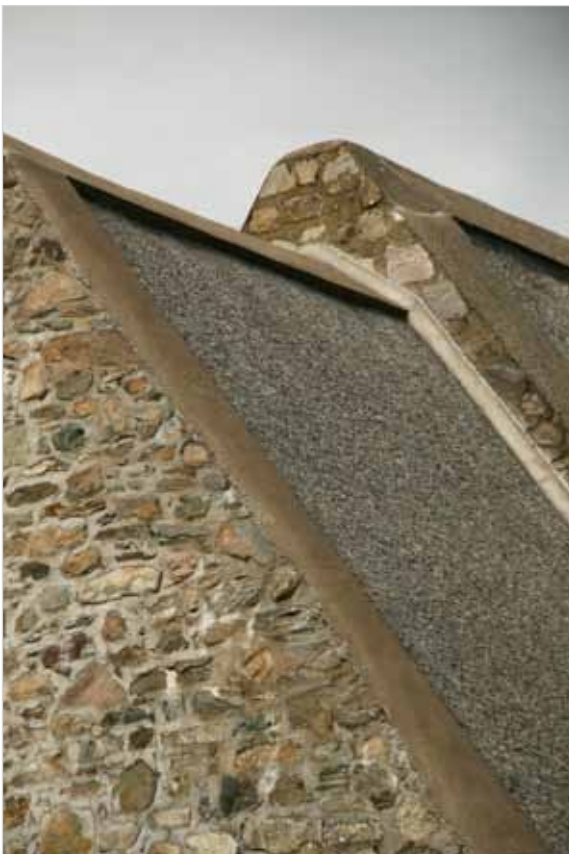
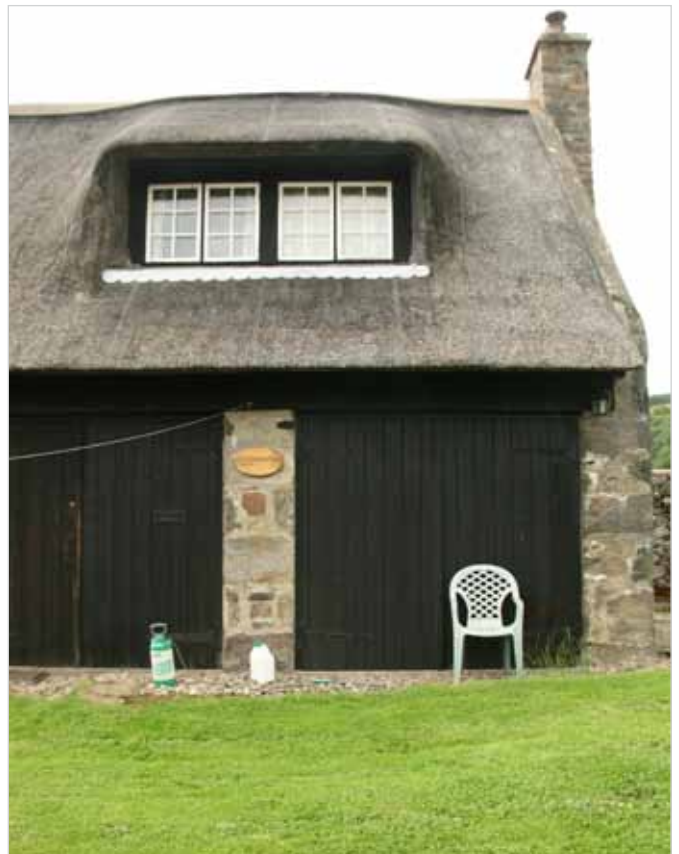
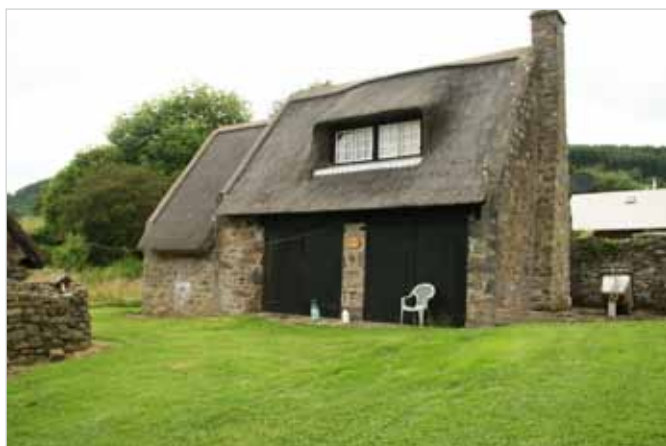
Garder Cottage – Perth & Kinross

Condition of Thatch: ..... Good

Additional Notes: Cottage with single-storey wing to the west, and a two-storey wing with double garage on the ground floor to the east. Both wings are thatched in what appears to be reed and have concrete ridges, which extend continuously down the skews of the building. The thatch is entirely netted with a small gauge wire netting. The east wing has a wide dormer window on the second storey. Whilst this building is not listed, there is a mention of it in the listing notes of the cottage to the south-west (listed building number 5756): *'Immediately to the NE of West Cottage is a small thatched building known as Garden Cottage. This was originally a single storey*

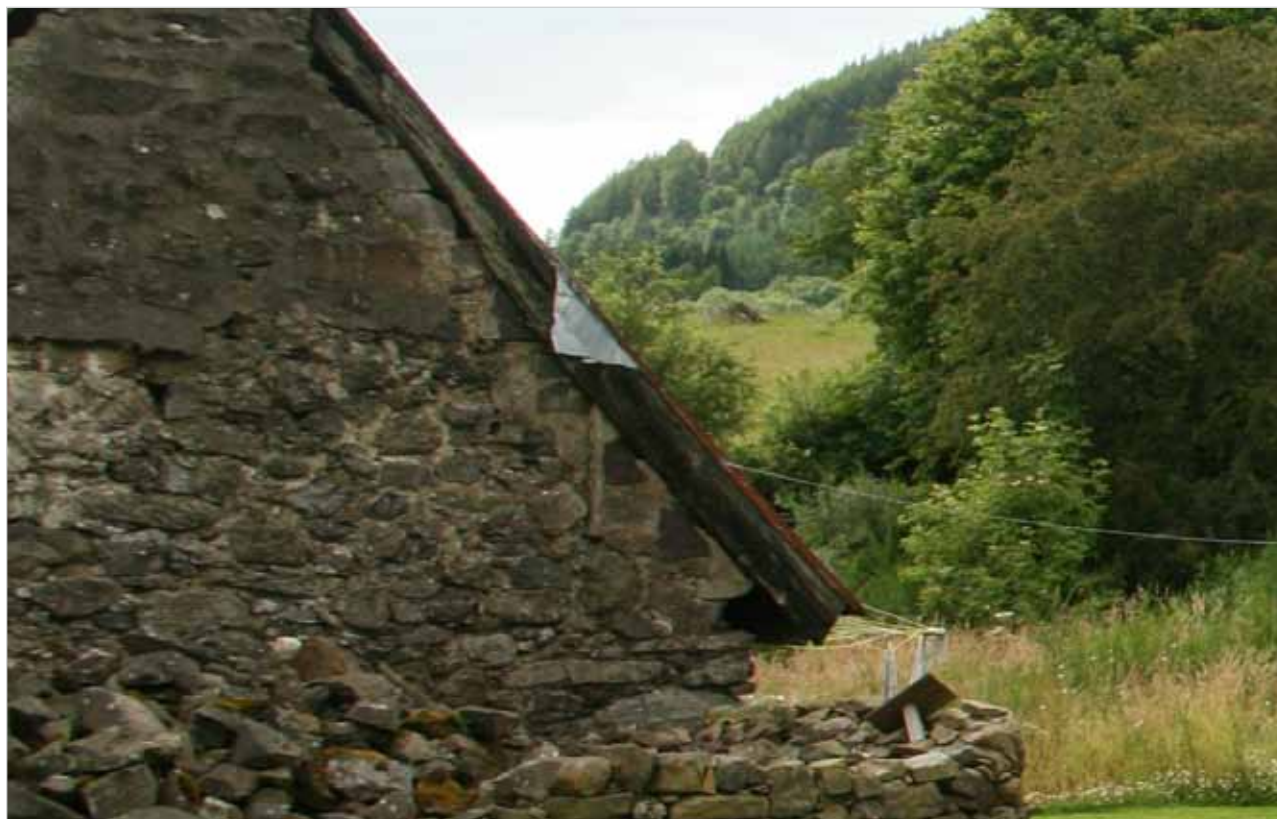
Additional Notes: ..... Probably 18th-century cottage, listed as '*retaining thatch under corrugated iron*'. The cottage is listed as part of a group, also with a bothy and barn. There was some confusion when visiting the site as to which building was the cottage, therefore confirmation of whether any thatch remains underneath the corrugated iron roof covering could not be gained.

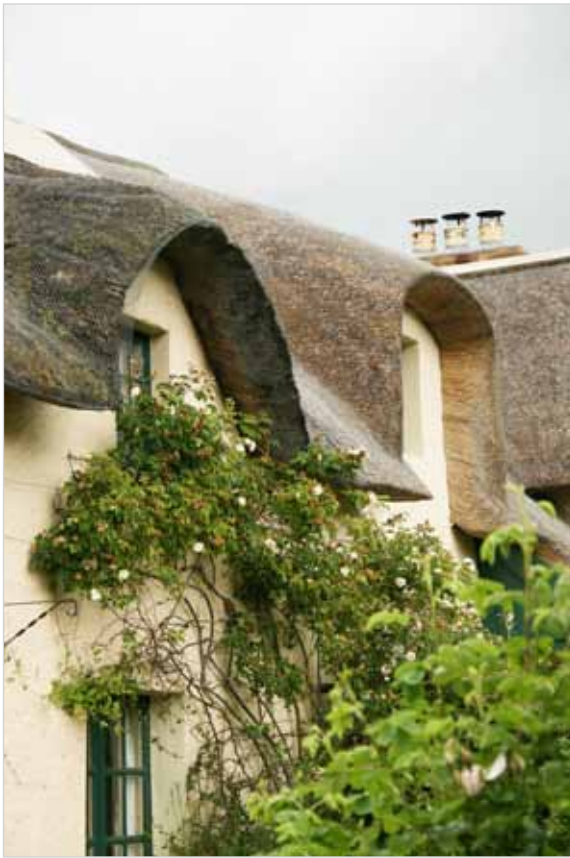
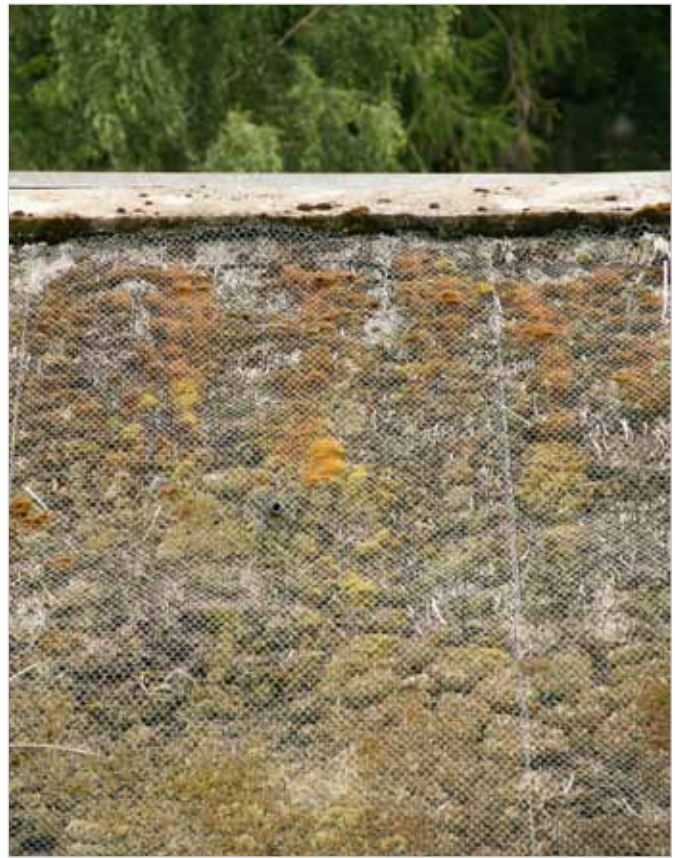
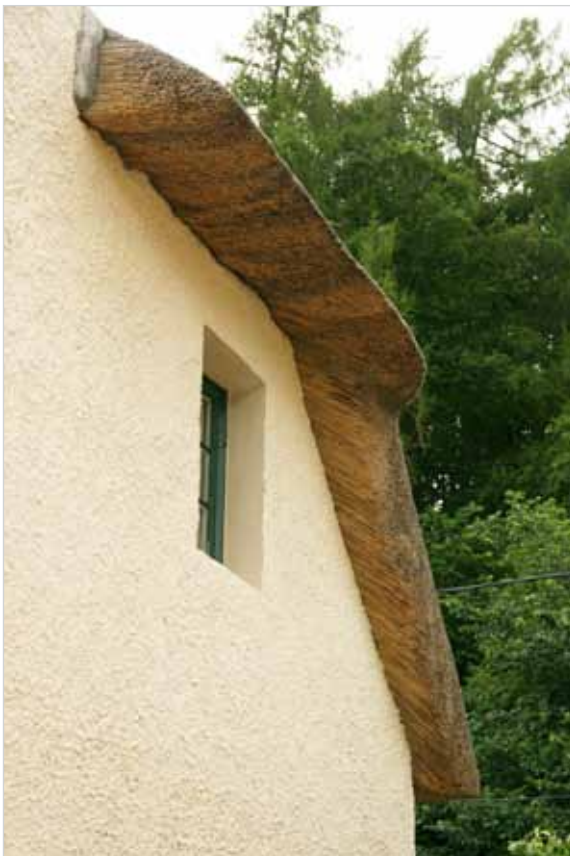
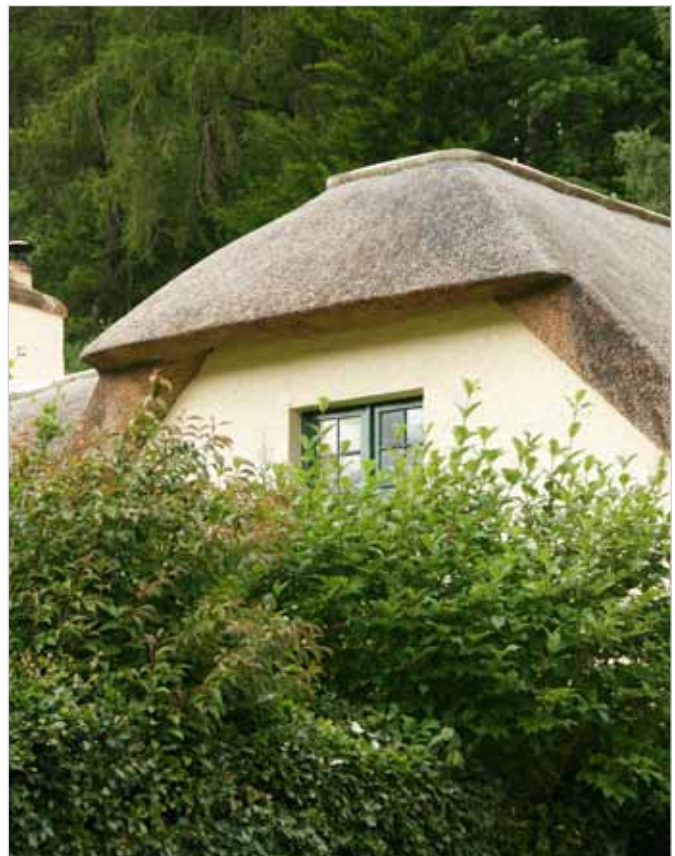
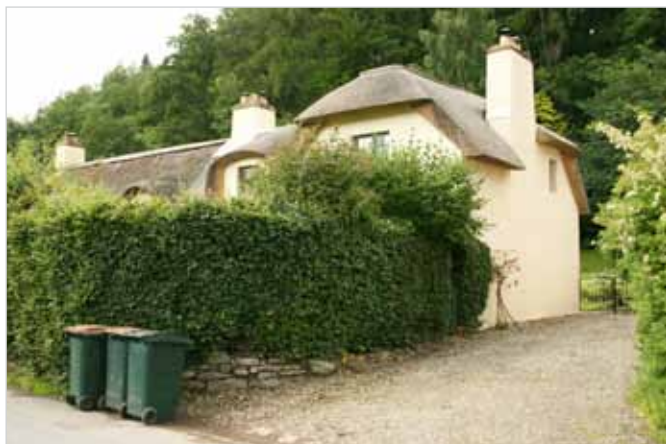
Mr Menzies' Cottage – Perth & Kinross

Condition of Thatch: .....

..... Good

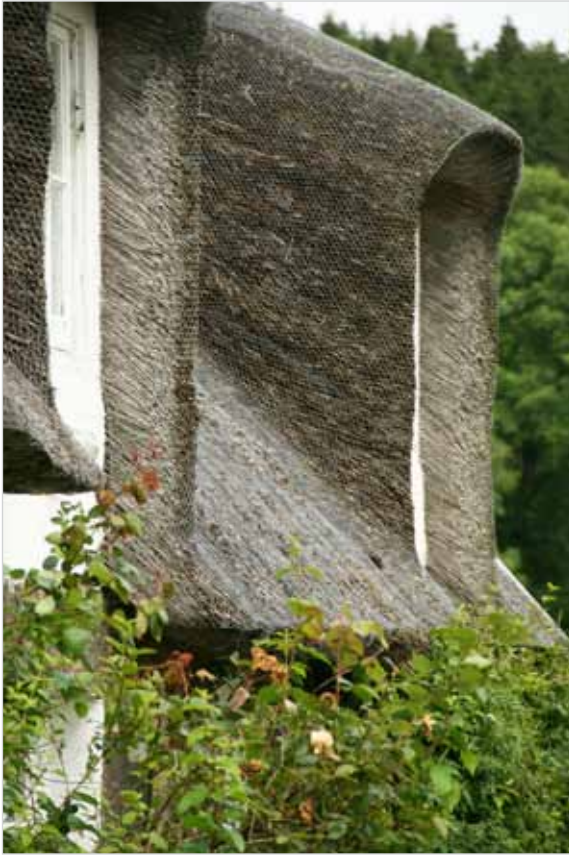
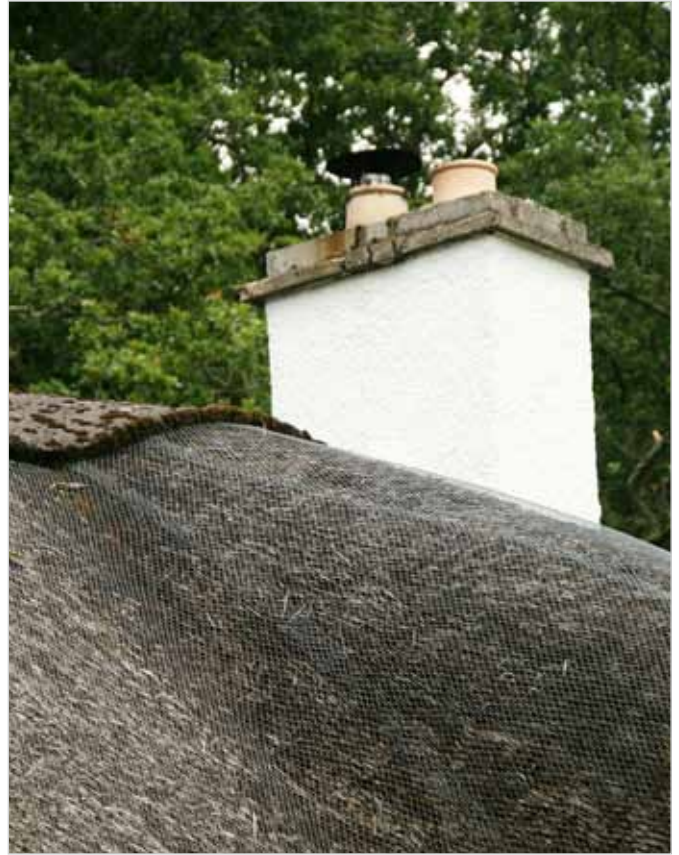
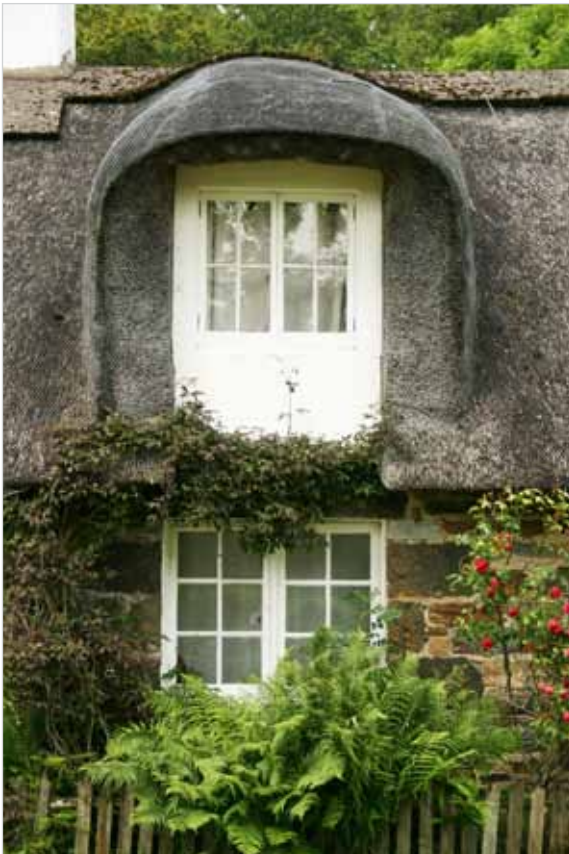
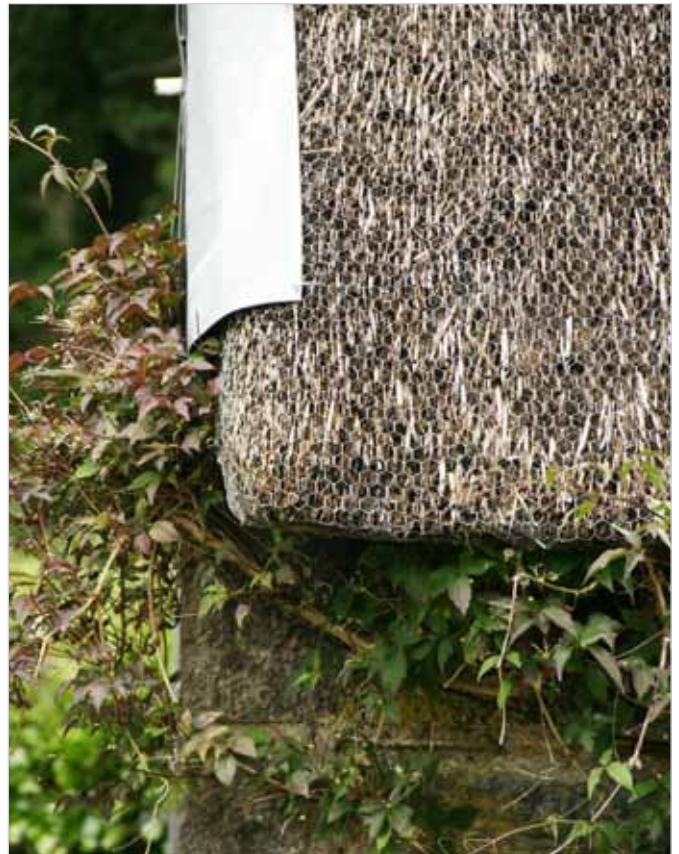
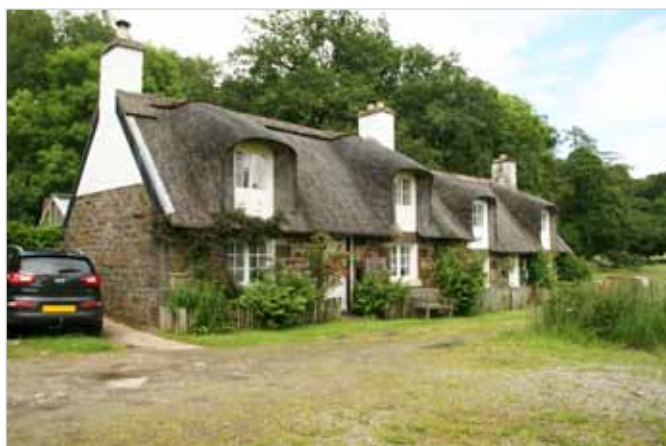
East Cottage – Perth & Kinross

Condition of Thatch: ..... Good

Additional Notes: ..... Circa 1900 single-storey cottage with attic and four dormer windows on the front elevation, listed as being thatched and by architects Dunn & Watson. The east half of the building has been stepped down to lower level to accommodate the topography of the site. The reed-thatched roof has a concrete ridge, which is raised above the dormer windows to accommodate the curve in the structure. The ridge also extends directly below each of the three chimney stacks, one at each gable end and one along the ridge. The thatch has been entirely netted and has been boxed in with timber and lead flashings at the skewes. There is an amount of

..... mossy vegetation growth along the ridge, as well as a small amount across the surface of the thatch underneath the netting.
